Manhole Inspection Summary

Manhole # S31II_002MH

Location Address: **123 LAFAYETTE AVE**

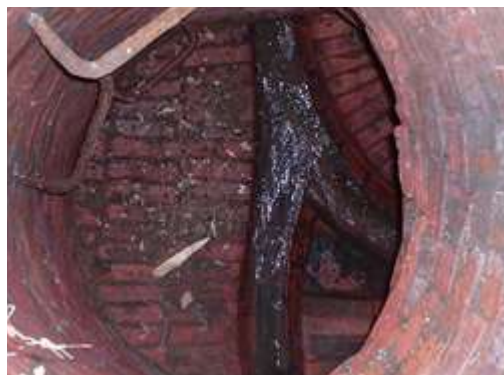
Top View

Barrel infiltration. Corroded steps. Bench debris.

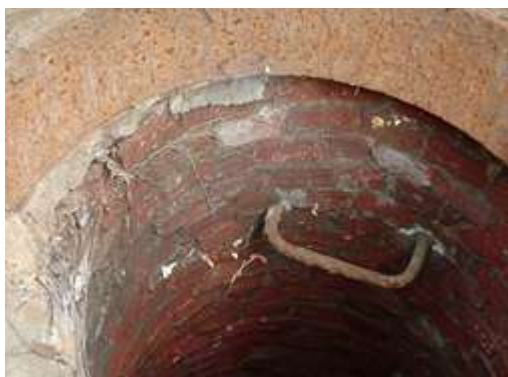
Defect

Frame leaks. Adjustment deterioration, root intrusion and infiltration - other side.

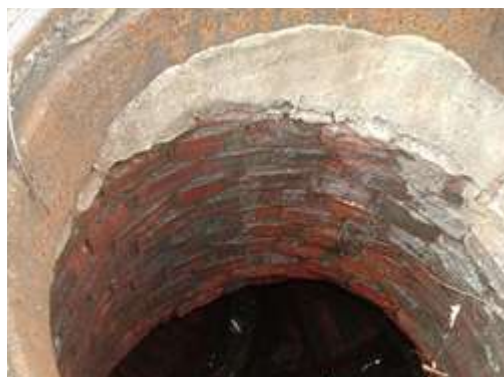
Defect

Frame leaks. Adjustment deterioration, root intrusion and infiltration.

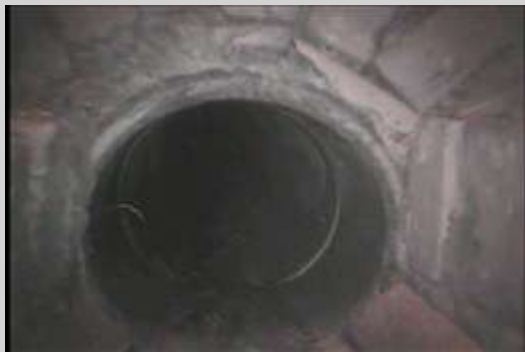
8 in. Circular Gravity Sewer Pipe Out @ 12 O'Clock

Infiltration: **Evidence** Pipe Seal Cond: **Roots**

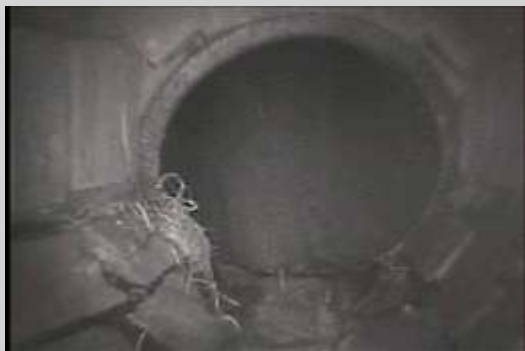
8 in. Circular Gravity Sewer Pipe In @ 4 O'Clock

Channel root intrusion.

Infiltration: **Evidence** Pipe Seal Cond: **Roots**

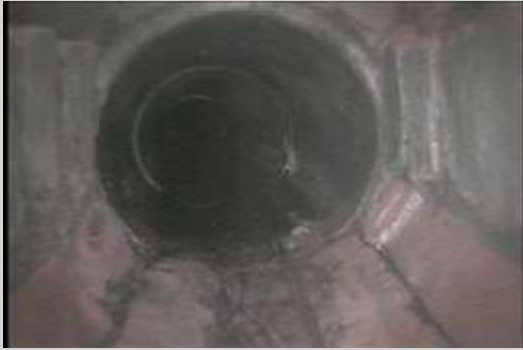
Pipe In @ 6 O'Clock

Channel deterioration.

Infiltration: **Evidence** Pipe Seal Cond: **Roots**
